UNITED STATES ENVIRONMENTAL PROTECTION AGENCY REGION 8

Subject: POLREP #1 (Initial Pollution Report) – Removal Assessment
Gold King Mine Site
Site #085M
Silverton, CO
Latitude: 37.8945 Longitude: -107.6384

Date: September 25, 2014

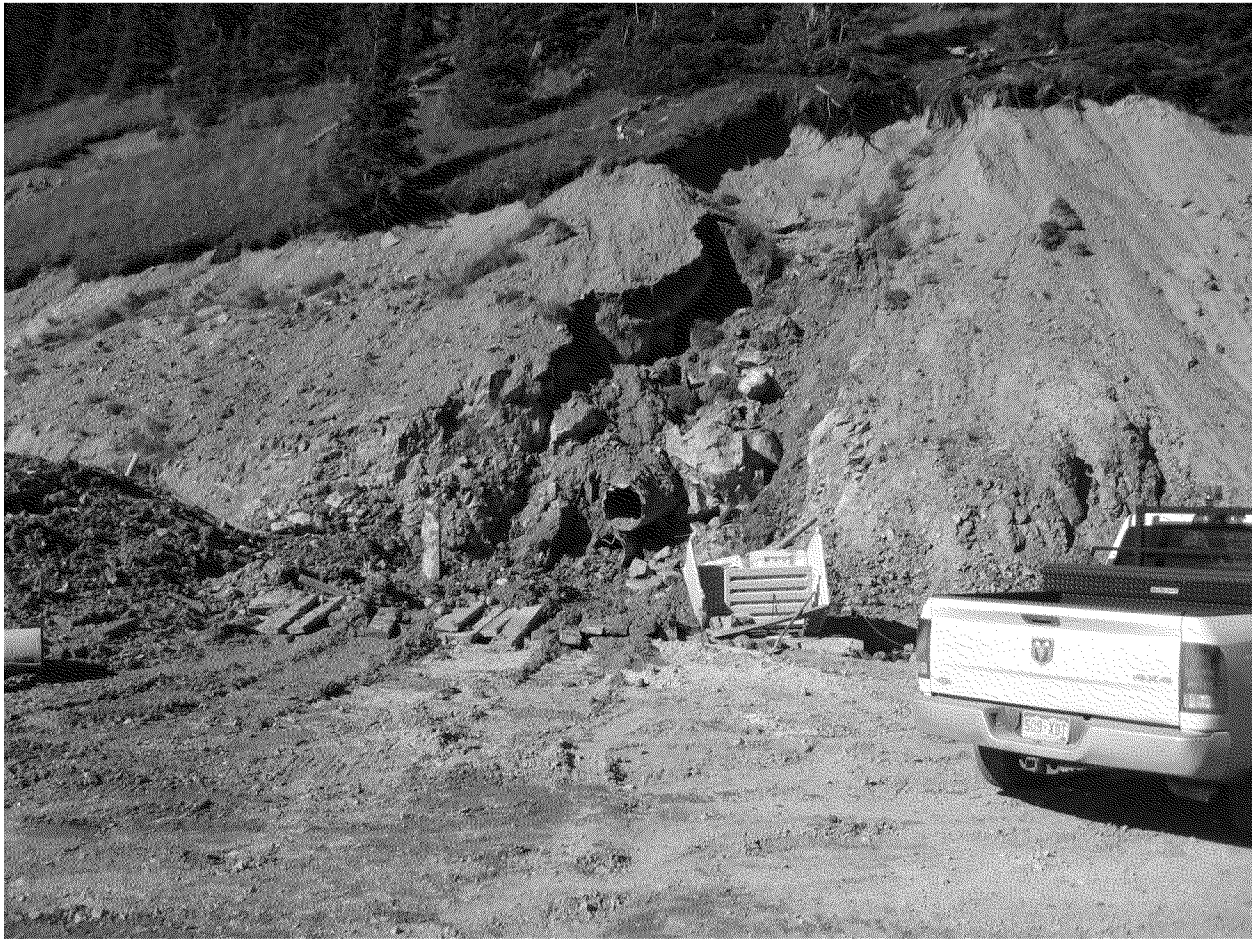
- The condition that was exposed revealed that two 24 inch pipe were in the tunnel blockage adjacent to the top (roof) of the adit. Timbers were observed on the sides and a cap timber was also observed by the contractor. The presence of the 2 – 24 inch pipe indicated the current flow of water was coming out only four feet below the roof, and then there was approximately 6 feet of impounded water below the level of the dump surface. (See Photo below)

Gold King Mine – 9/11/14: collapsed adit pipe near roof of the adit/tunnel.

- The following day, the drain pipe (2 - 12 inch) were placed at the base of the blockage to capture the on-going mine drainage and direct flow into the existing concrete flume channel previously installed at the Gold King 7th Level Mine collapsed portal. In order to do route the water into the channel, a section was removed from the concrete channel north wall (approximately 26" by 10") to allow for construction. The two 12" diameter PVC (polyvinyl chloride) pipes were installed to better direct adit drainage water from the portal into the concrete channel. Geo-fabric, crushed rock, and quick-dry concrete was used to secure the pipes in place. The portal area was backfilled and compacted with additional loads of crushed rock to maintain a stable surface at the portal for potential future work.
